Hyundai HQP 421 SR 42” Plasma TV
Power supply is labelled LJ44-00068A v3.0 PS-423-SR and is common in early 42” plasma TV’s

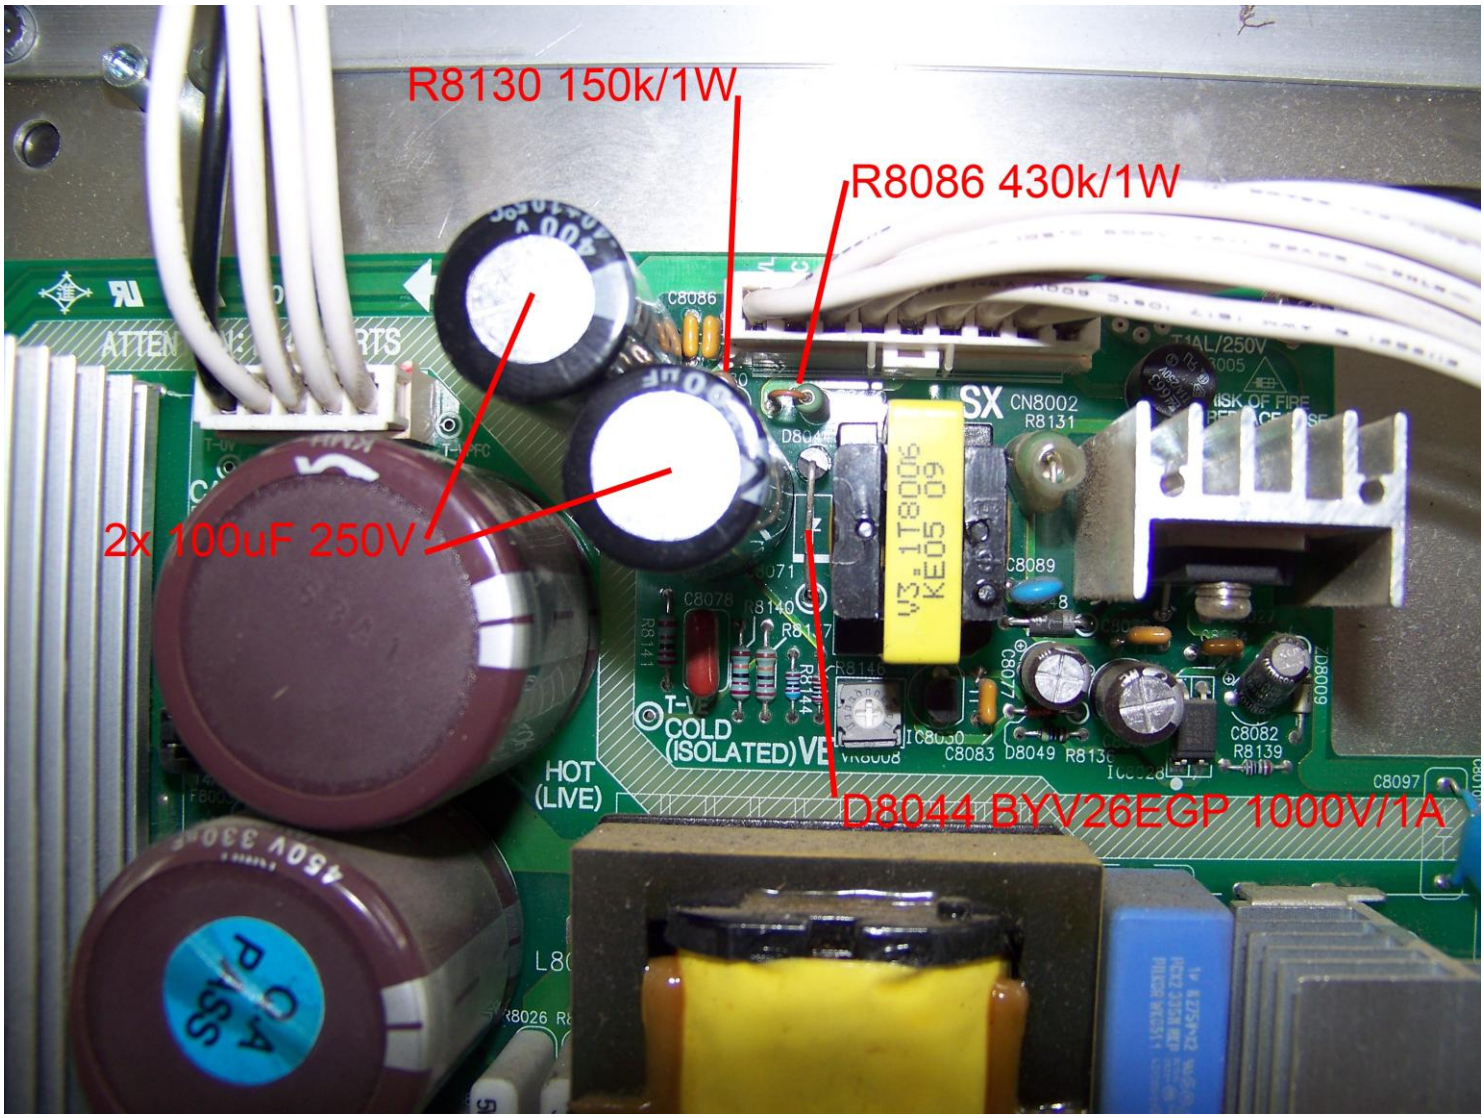
Fault Symptoms:

- Turns on then off after about 10 seconds.
- Red “Protection” LED comes on.

Check / replace components in VE power supply area as shown below
Adjust VE for +165V or as shown on PDP label
